MOENJODARO: A WORLD HERITAGE SITE AT RISK

Enrico Fodde and Muhammad Safdar Khan

The aim of this paper is to describe the main threats affecting Moenjodaro, an archaeological site that prospered from 2350 to 1800 BC in the fertile Indus flood plain of Sindh (Pakistan). The major hazard is today represented by soluble salts attack (mainly sodium sulphate), rising damp, heavy precipitation in the monsoon season, poor drainage, thermal stress causing walls to lean and decay structurally, visitor behaviour, site mismanagement, and the lack of vegetation. As a result of poor conservation and bad management, in the year 2000 the site was inscribed in the ICOMOS register of heritage at risk. The paper analyses past and present conservation methods, and provides recommendations for future repair and maintenance.

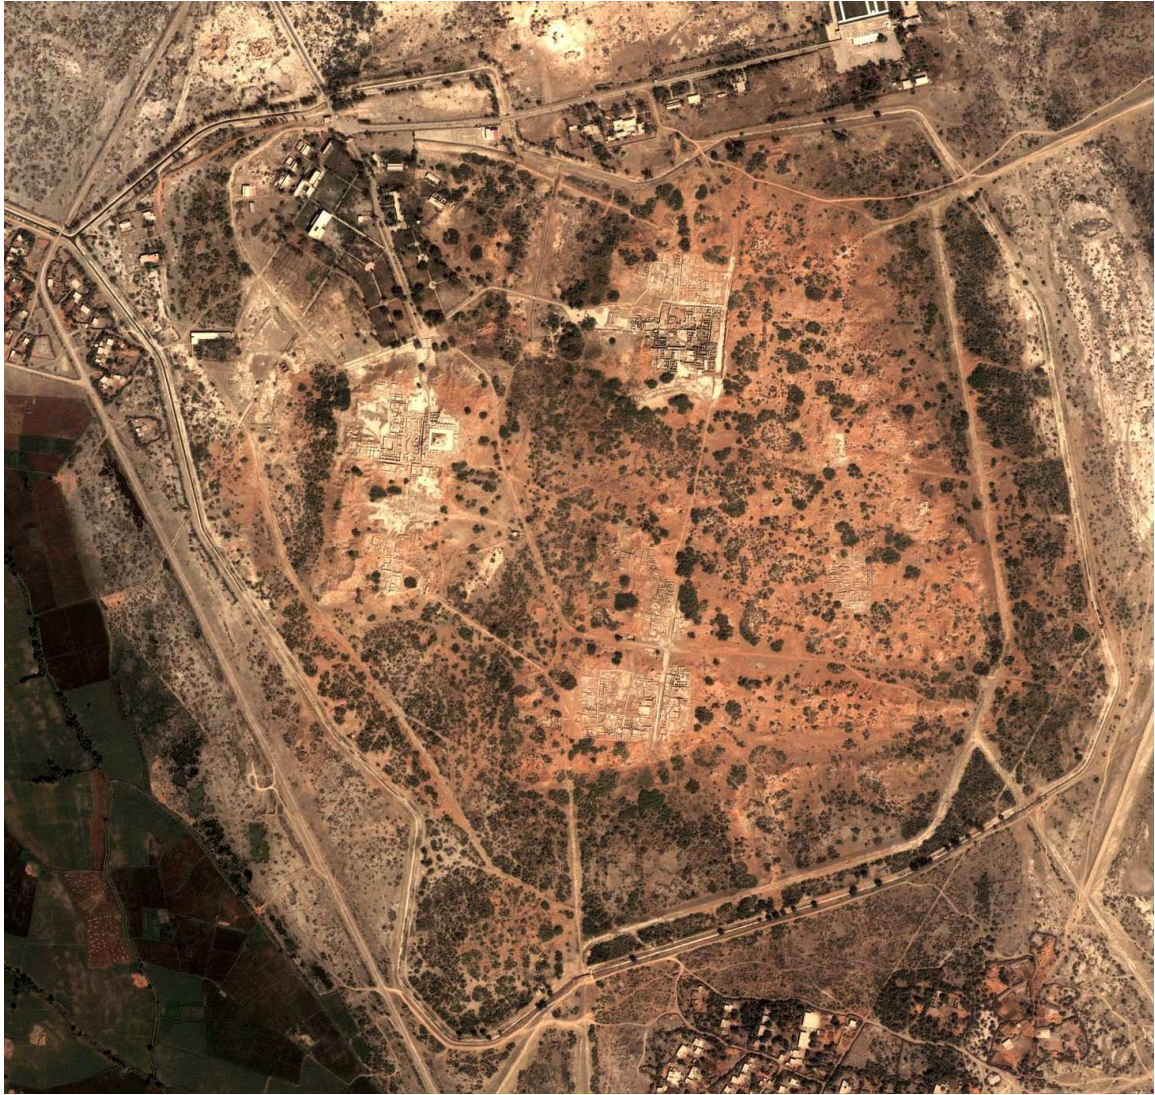
Compared to other conservation tasks mentioned in the Master Plan, plantation was given a low priority because not considered urgent and is still neglected today. Between 1994 and 1997¹⁷ the Forest and Wildlife Department (Government of Sindh) undertook a study of the flora of Moenjodaro and a new survey of the native species was completed in 2005 as part of the MCRC management (Table 2). It is clear that in the photosynthesis process indigenous plants use salts in the form of ions that are transported to the leaf stems. Native vegetation thus has the ability to tolerate salts. The

Figure 2: Satellite picture of the site of Moenjodaro (2003) showing lack of vegetation between excavated areas (see also Figure 3)

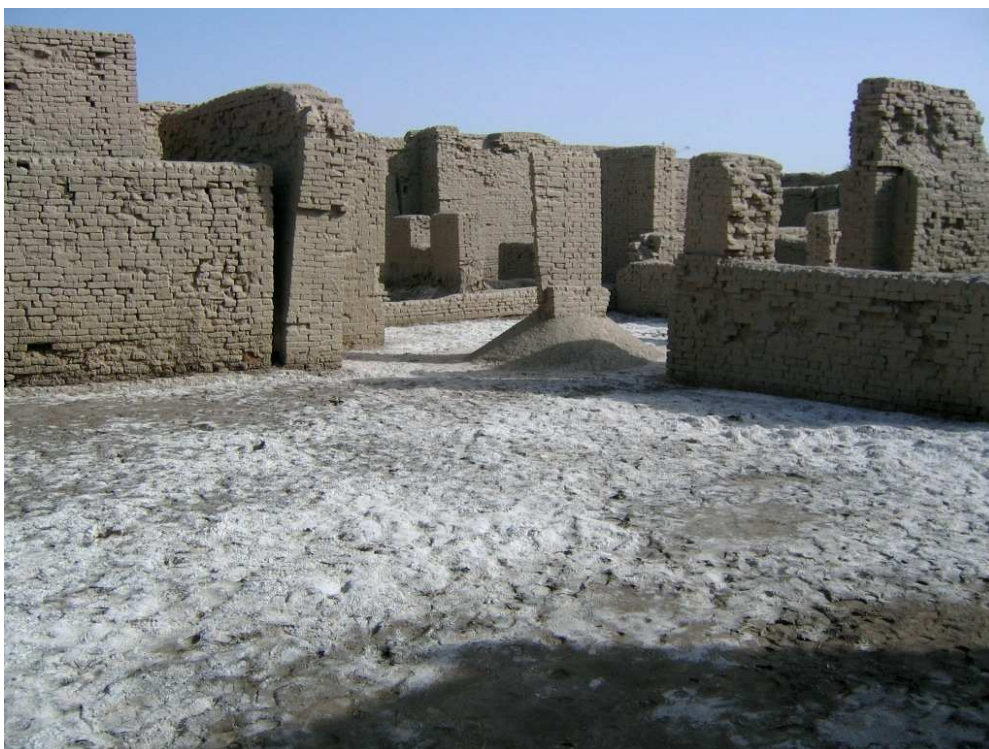
- Subsoil water is driven upwards by capillary action through the structures and in so doing it carries soluble salts. Such salts effloresce on the brick surface if the evaporation is slow, and sub-florescence if the evaporation is fast (Figures 8 -11).
- Hygroscopic salts, such as sodium sulphate, draw water from the air and are put in solution.⁹ Phenomena of hydration and dehydration occur because of temperature cycles, and this creates great pressure for both brick and mortar that tend to powder in response. If the evaporation is slow not only does powdering take place, but also chunks of bricks fall apart.

Figure 8: Picture showing DK-G area with salts affected soil

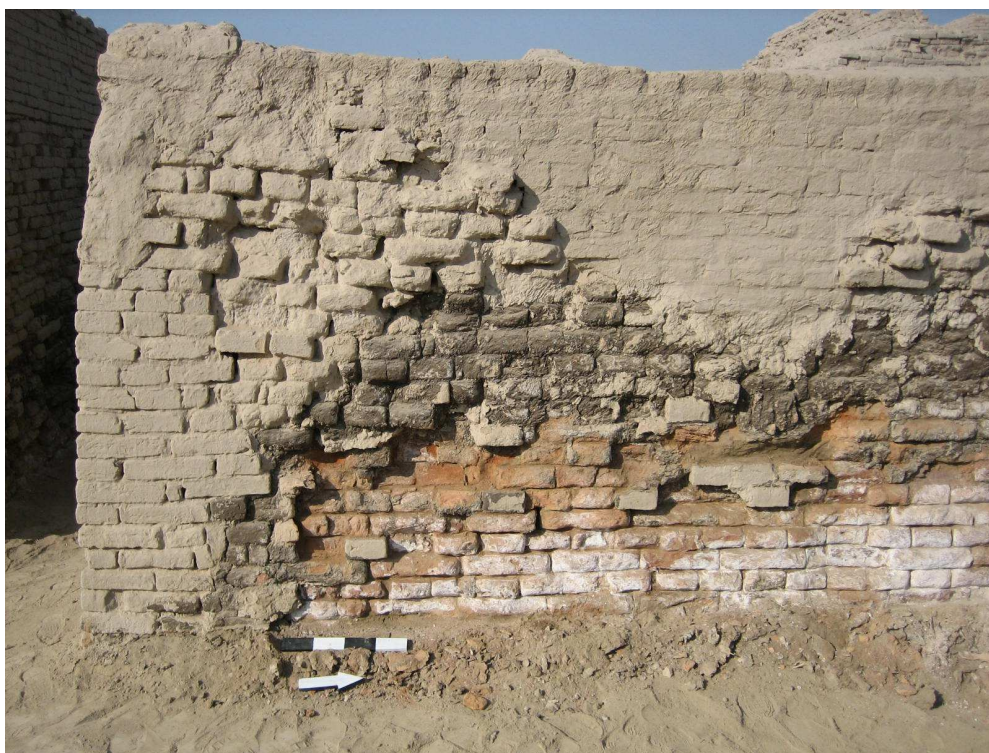
During the winter, salts tend to crystallize mainly on the northern and western elevations and sometimes on the eastern faces when in shade because the favorable temperature for crystallization is 32 degrees C. In the summer the phenomenon takes place within the brick fabric with the result that masonry tends to spall (sub-florescence). Mud slurry is the best and least expensive remedy for protecting fired bricks from salts weathering¹⁰. Furthermore, mud plaster is effective against sub-florescence as it can minimize heating of the structures to some extent. The data provided in Table 1 show that the most common salts are sodium, potassium, calcium, magnesium, carbonate, bi-carbonate, nitrate, nitrite, chloride and sulphate, with sodium sulphate and sodium chloride found in abundance. The analysis on Table 1 further shows that the amount of salts decreases with the increase in depth, which suggests that their concentration is higher at the surface due to evaporation.

Figure 9: Soluble salts attack, Main street, DK-G area

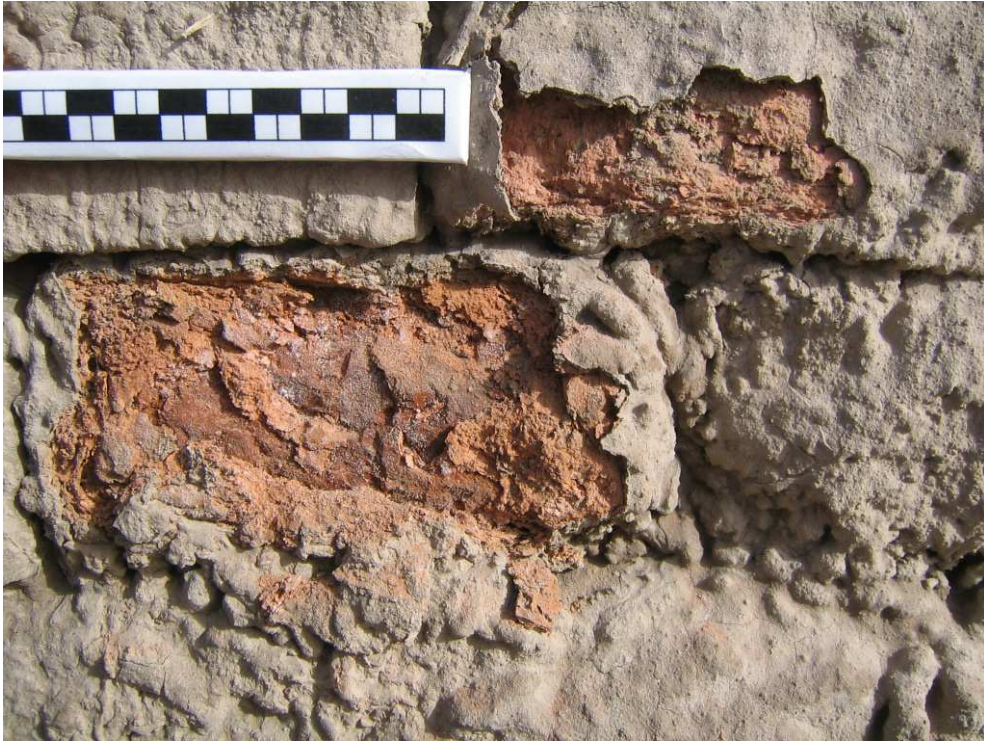
Figure 10: Close up of salts attack showing that when crystallization occurs below the surface (subflorescence) damage occurs

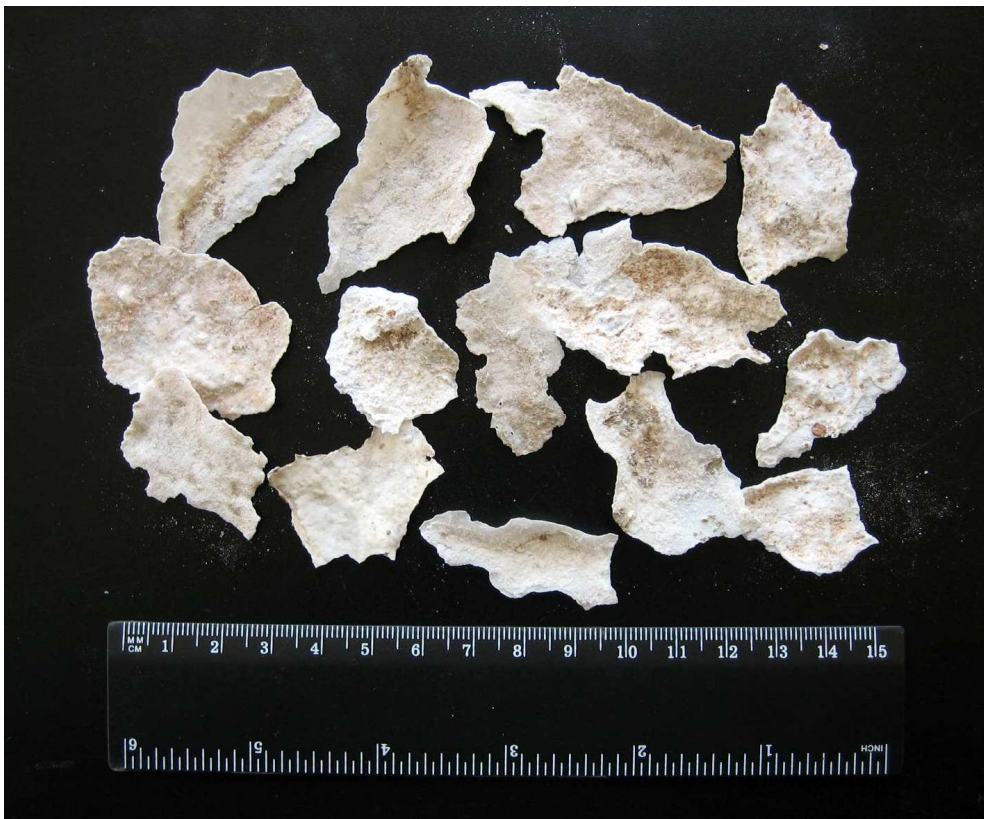
Figure 11: Sodium sulphate crusts as collected from one of the walls of DK-G
